CASE STUDY
*M&S Store,
Lake District*

SOLUTION
Asphalt
Repairs,
Drainage
Repairs and
Lining Refresh

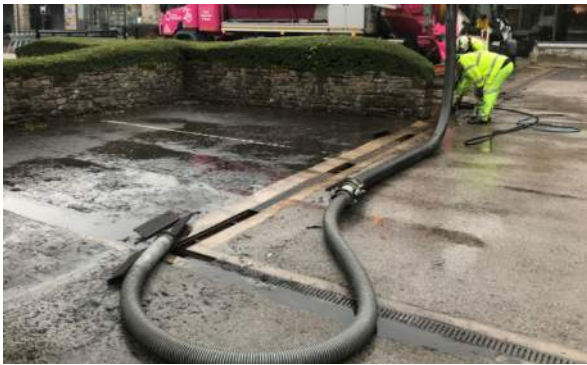
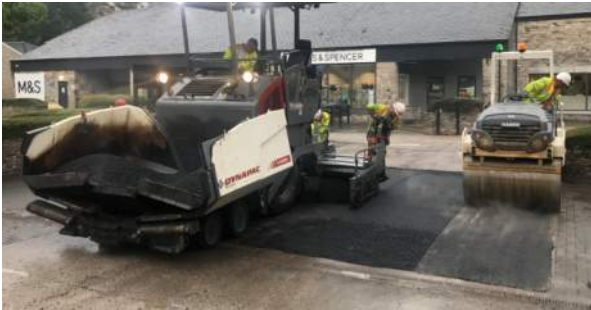
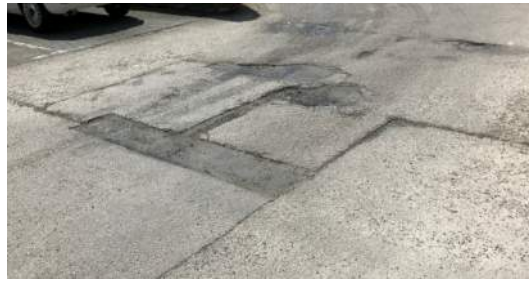
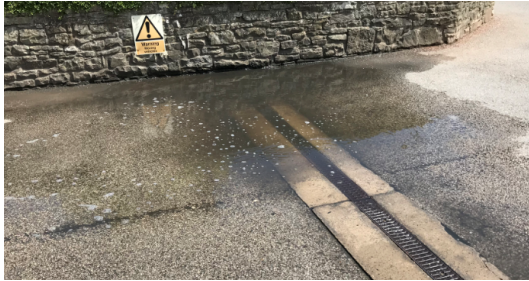
Our client contacted us as their car park was constantly flooding and various areas rutting and potholing. We attended site and carried out a full condition survey. Results found that all linear drainage was blocked on site with silt, causing any rainfall to pond on site. This was slowly damaging the asphalt and with the severe winter we had this year, the surface had deteriorated drastically.

Firstly, it was our main interest to rectify the drainage issues. We advised to JETVAC all the drainage on site cleaning them of any silt and debris thus allowing them to flow freely. Working with our clients budget constraints, we then highlighted areas of asphalt repair which posed a Health & Safety risk to customers. Finally, we advised a full lining refresh as all directional arrows and giveaway junctions had faded.
